# Old before their time

**Cal Chapman, P. E., Chapman Engineering, Inc., USA**, asks: who really wants to install a liability?

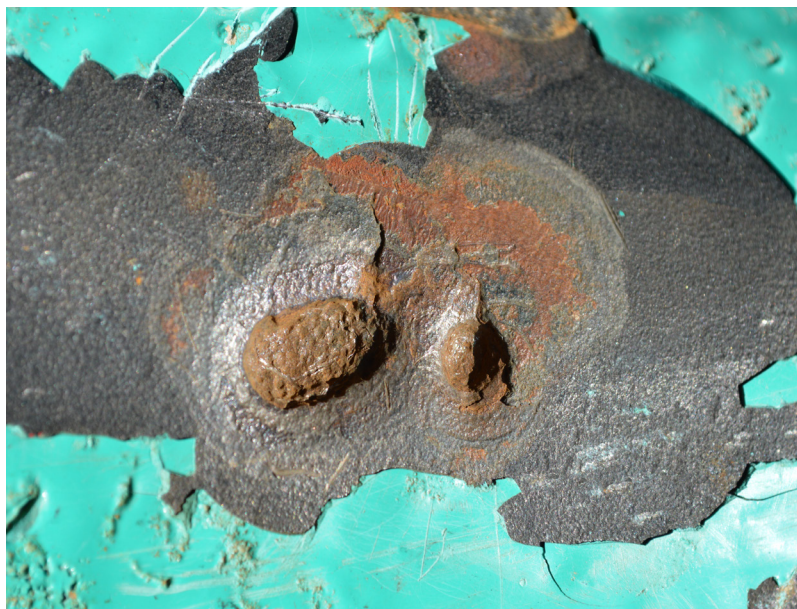
Oil gathering pipelines in a Texas (USA) shale region were hustled into the ground with terrible ‘in the field’ coating work, and no cathodic protection (CP) was applied until 30 months later (Figure 1). How was trouble identified? Three liquid product leaks were found in a local river crossing area within a 45 day span, with threat of environmental consequences. Alignment sheets generally showed reasonable materials specified, bored crossings of roads and creeks laid out well in design

**Figure 1.** A 0.3 in. wall, 6 in. elbow with field coating. Pits were not evident until the removal of never-adhered (but intact) field-applied coating in the shop; corrosion product still partially fills both pits, one of which was 0.24 in. deep (80% wall loss). Note that coating had not cured before backfilling began. A through-wall external corrosion pit was found several inches to the right, at a girth weld.
