HIGH-VOLTAGE RISKS

Cal Chapman, Chapman Engineering, USA, discusses the various threats to safety and integrity that can arise from pipeline interference.

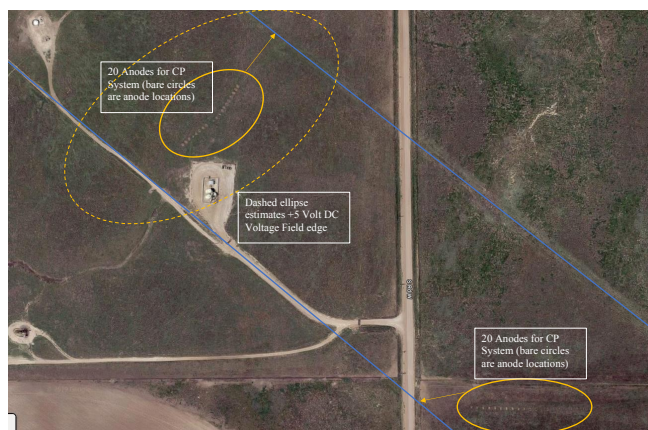
Figure 2. Two pipelines, each with a CP system causing influences.

In Figure 2, each pipeline is seen to have a 20-anode 'conventional' anode bed installed (the two beds shown inside yellowed ellipse outlines), with each anode bed showing circular 'dead grass' patterns over anode locations. For the CP system at the upper left, protecting the more northerly pipeline, it was recently using approximately 80V DC to deliver 85A DC of

protective current. This 80V maximum field strength is so potent, and the electrochemical reactions at each anode so aggressive, that the soil dead grass spots appear. These anodes, likely around 5 ft in original length and 2 - 3 in. in diameter, were installed in vertical borings. While the burial depth should have been 15 ft or 20 ft for the bottom of each anode, the dead circles suggest that anodes were buried to shallower depths.

As each anode has positive DC driven from it, with that current then flowing through soils to deliver protective current to exposed pipeline metal, the anode surface and soils beside it are chemically acidified. As a result of these chemical reactions taking place, water as soil moisture is consumed, and the local soils immediately around each anode dry out severely. The actual temperature of soil beside and above each anode may increase. All of these factors contribute to plants dying above and around each anode.

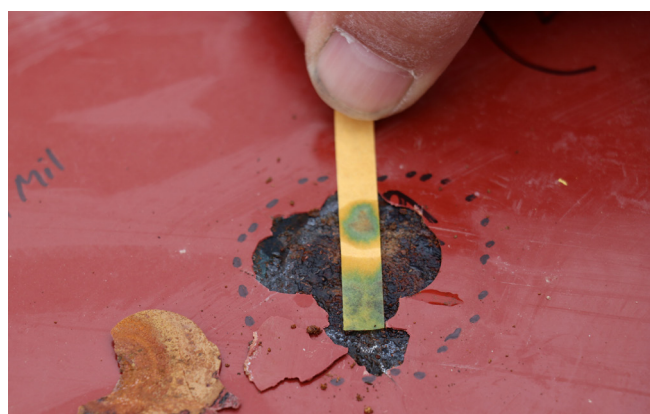
Figure 4. In-between dig and exposed pipeline metal with acidic conditions.

The litmus paper in Figure 4 shows a pH in the range of 8 - 8.5. Because the pH scale is logarithmic, a change from 8 to 9

represents an increase in alkalinity by a factor of 10. Comparing this pH with the earlier one, a change in pH from 8.5 to 12.5 represents a factor of 10 000 difference in alkalinity or acidity. CP was being applied at each position on this pipeline, since the pipeline was made of continuous carbon steel. However, the amount of effective CP applied at the defect was approximately 0.01% of that applied at two pipe locations, to the west and east of this defect. This is caused only by foreign CP currents being present, and counteracting the operator's CP current at this defect, while they add to the CP effect at the other two reference locations.
